## Fatalgrams and Fatal Reports

Fatality #3 - March 11, 2005
Falling/Sliding Material - KY - Limestone (C&B)
Grassy Stone LLC - Grassy Stone LLC Mine

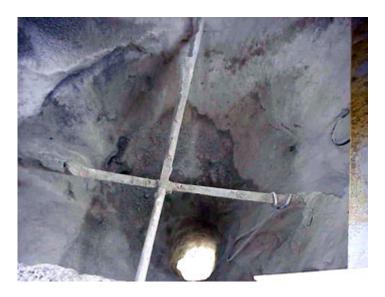
**METAL/NONMETAL MINE FATALITY -** On March 11, 2005, a 23-year-old laborer, with one year mining experience, was fatally injured at a crushed stone operation. The victim had entered a bin and was attempting to dislodge material that had adhered to the inside walls. The victim was not wearing a safety belt secured to a lanyard. He was engulfed when the material suddenly broke free.

## Prior to entering bins, hoppers, tanks, or silos:

- Ensure supply and discharge operating controls are locked out.
- Ensure a safety harness properly secured to a lanyard is worn and a second person is positioned outside to adjust the lanyard.
- Ensure miners have been trained to safely perform the task.
- Miners should discuss the work procedures, identify all possible hazards, and ensure steps are taken to safely perform the task.
- Management should routinely monitor these activities to ensure miners are protected from possible hazards.
